# Manhole Inspection Summary

Manhole # S17II\_021MH

Insp Date: **6/12/07 8:02 AM**

**Location** Address: **2212 WESTWOOD AVE**

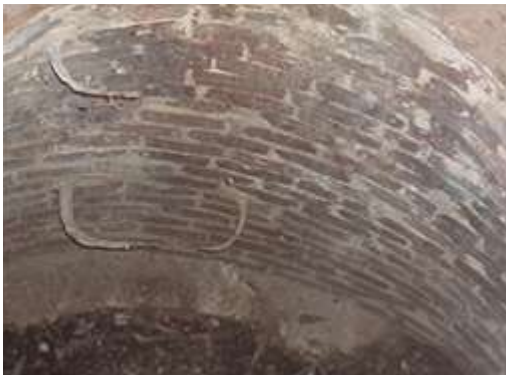
Defect 2

Count: **0** Missing: **3** ☒ **Corroded**

MISSING STEPS

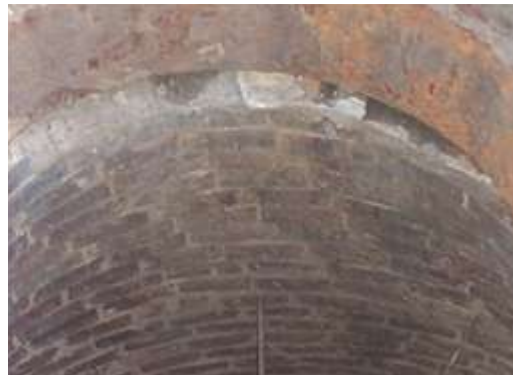
Defect 1

Condition: ☐ Sound ☐ Cracked ☐ Root Intrusion ☐ Loose Brick ☒ **Deteriorated**

DETERIORATION OF CHIMNEY

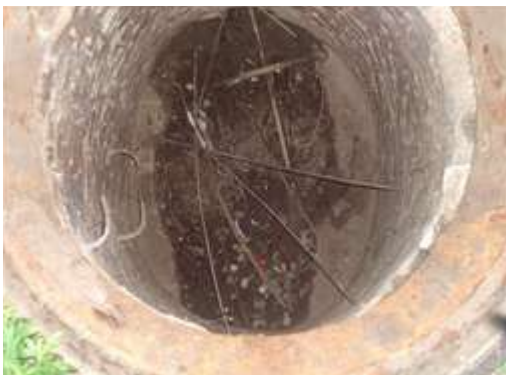
Defect 3

Condition: ☐ Sound ☐ Cracked ☐ Root Intrusion ☐ Deteriorated ☐ Leaks ☒ **Debris**

DEBRIS IN CHANNEL

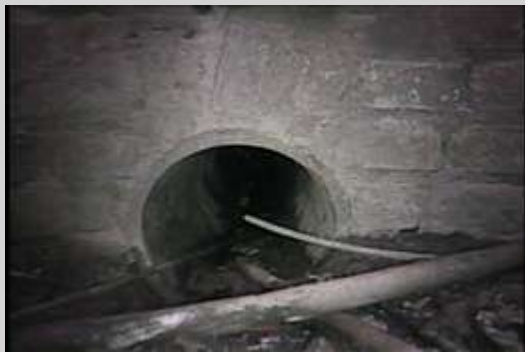
12 O'Clock Outflow

8 in. Circular Gravity Sewer  
Pipe Out @ 12 O'Clock

Deposits: ☐ None ☐ Mud ☐ Sludge ☒ **Debris** ☐ Grease

Silt Depth: **1** (in.) Deposits Extent: **Light**
